## Rigifa, Thurso

# Phase 2 Ground Investigation Report

**Curtins Ref: 085449-CUR-00-XX-RP-GE-00002**

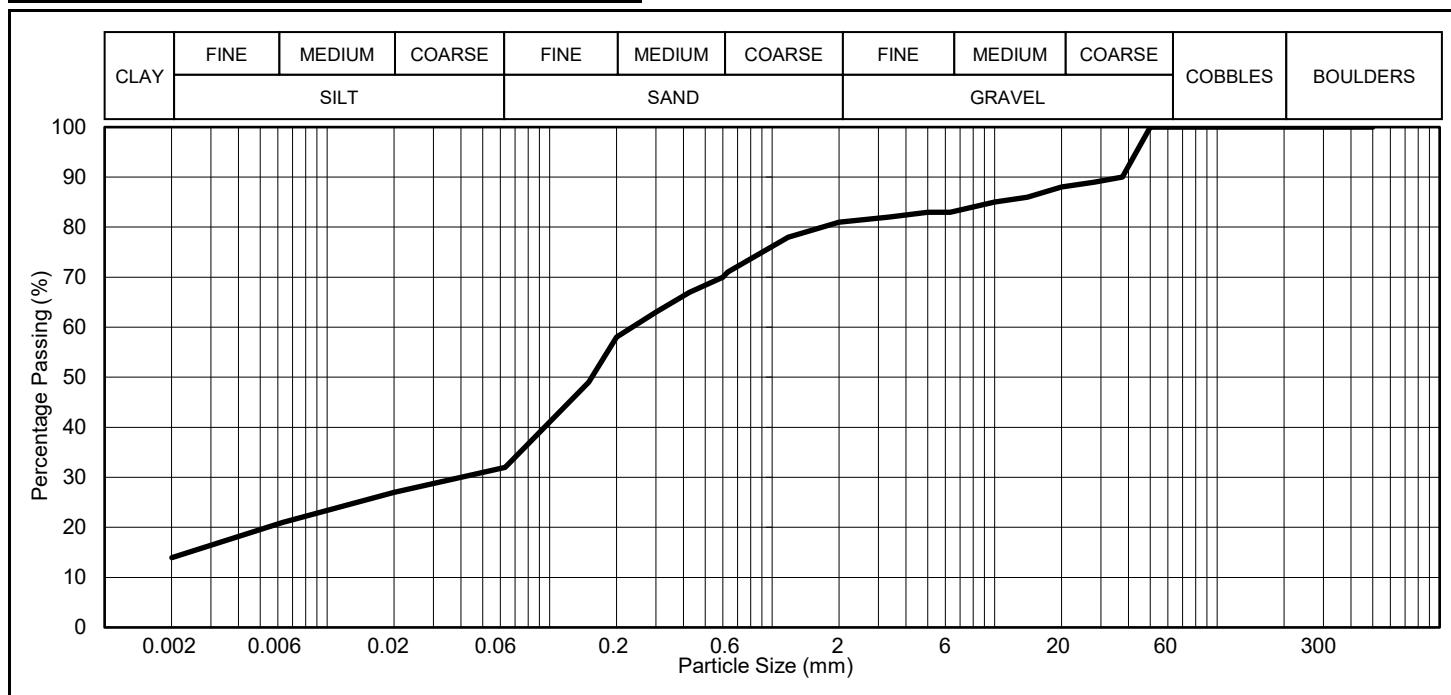
Borehole	BH05
Sample	B
Depth (m)	1.80

SIEVING				SEDIMENTATION (Assumed ps of 2.65Mg/m³)				
Sieve Size (mm)	Percentage Passing (%)	Specification		Particle Size (mm)	Percentage Passing (%)			
		Not Applicable						
		Lower %	Upper %

500.0	100	-	-	0.0200	27			
300.0	100	-	-	0.0063	21			
125.0	100	-	-	0.0020	14			
90.0	100	-	-	GRADING CLASSIFICATION (SHW TABLE 6/2)				
75.0	100	-	-					
63.0	100	-	-
